# Kadena F-15C crash report

**Attrition Report**  
**AIRforces Monthly**  
**Aug 2019 Issue 377**

**A** PACIFIC Air Forces Accident Investigation Board (AIB) report into the loss of a US Air Force F-15C near Kadena Air Base, Japan, on June 11 last year, found pilot error caused the crash. Adding to our original story (see *Attrition*, August 2018, p92), the official report – released on April 23 – identifies the aircraft as F-15C 84-0008 'ZZ' from the 18th Wing's 44th Fighter Squadron (FS) 'Vampires' at Kadena.

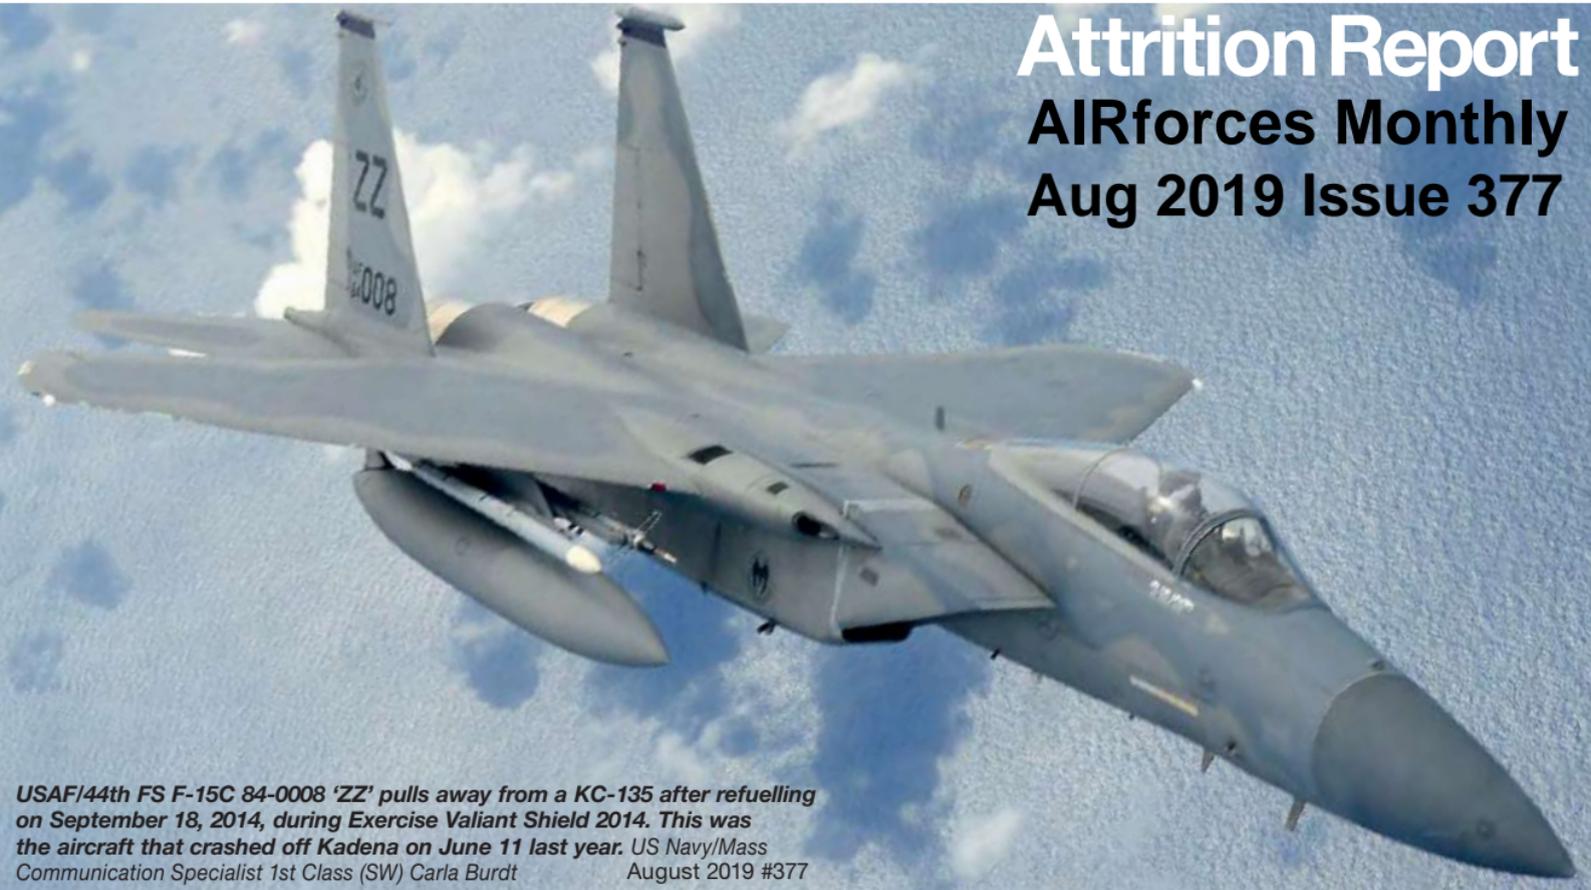
***USAF/44th FS F-15C 84-0008 'ZZ' pulls away from a KC-135 after refuelling on September 18, 2014, during Exercise Valiant Shield 2014. This was the aircraft that crashed off Kadena on June 11 last year. US Navy/Mass Communication Specialist 1st Class (SW) Carla Burdt August 2019 #377***
