EXECUTIVE SUMMARY
AIRCRAFT ACCIDENT INVESTIGATION

F-16C, S/N 85-1474 MISHAP

**113th WING, 121st FIGHTER SQUADRON, ANDREWS AIR FORCE BASE,
MARYLAND**

3 NOVEMBER 2004

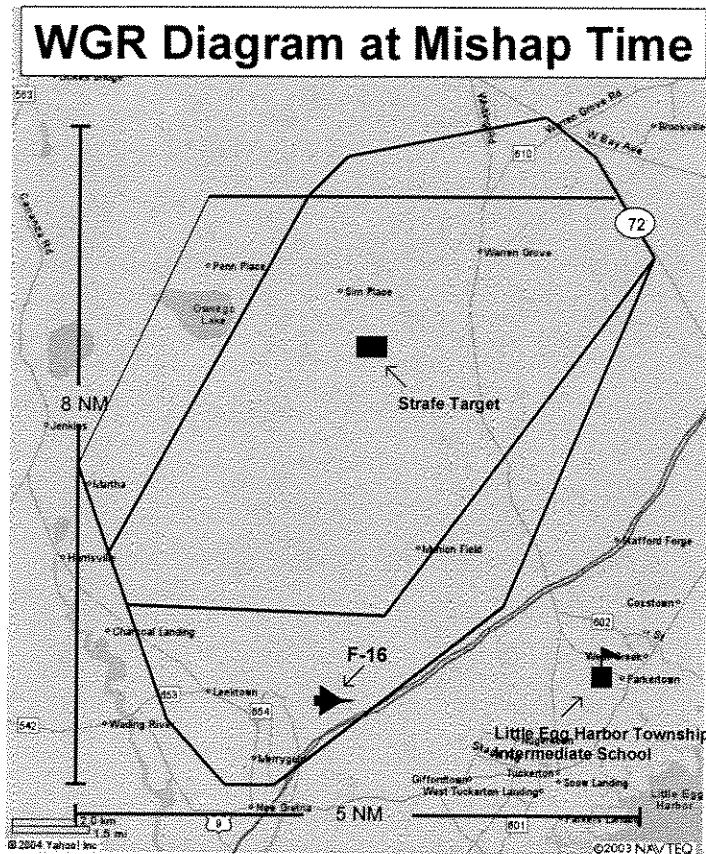
The below figure indicates the approximate relative positions between the mishap aircraft, the strafe target within the Warren Grove Range, and the Little Egg Harbor Township Intermediate School.
