UNITED STATES AIR FORCE
AIRCRAFT ACCIDENT INVESTIGATION
BOARD REPORT

F-16CJ, T/N 91-0340

480TH FIGHTER SQUADRON
52D FIGHTER WING
SPANGDAHLEM AIR BASE, GERMANY

DATE OF ACCIDENT: 8 OCTOBER 2019

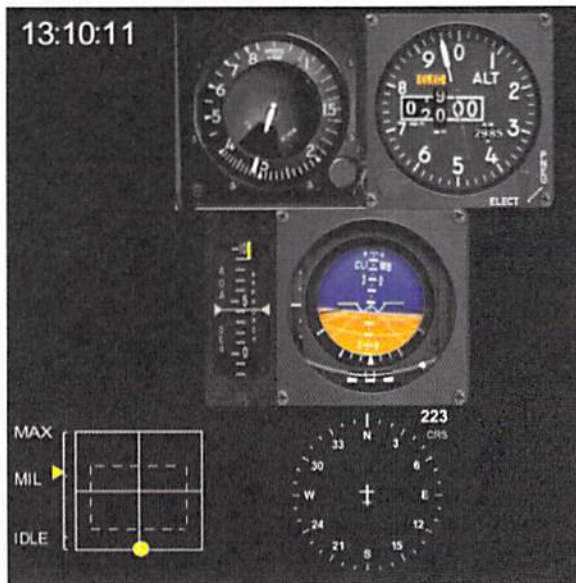
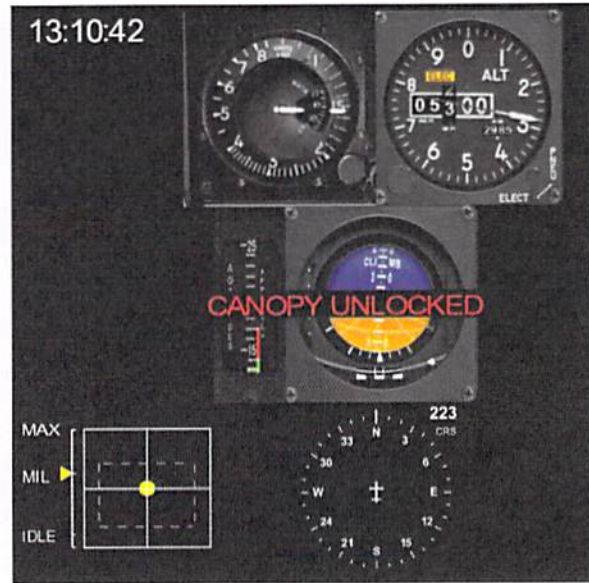
Figure 3: Second Minimum Altitude (Tab L-15) Figure 4: Parameters at Ejection (Tab L-15)

At 1 minute after take-off, the MA descended to 760 feet above field elevation with the parameters in *Figure 3* (Tab J-36). The MP reported seeing trees again and initiated another aggressive wings-level climb away from the ground (Tab V-11.10). At 15:10:22L the MP attempted a PARS recovery for a second time without success due to the EGI being offline (Tab J-37, J-42 and V-11.10). As the MA climbed away from the ground, the airspeed bled off below 200 KCAS (Tab J-36 and R-23). The MP assessed if the MA were to go below the weather a third time, the MA would not have sufficient energy or airspeed to maneuver away from the ground (Tab R-23 and V-11.11). The MP made an advisory call to MF1 stating, “{inaudible}...descent, two’s ejecting,” and at 15:10:42L, 1 minute and 31 seconds after take-off, the MP commanded ejection with the parameters depicted in *Figure 4* (Tab N-4 and J-37). *Figure 5* uses extracted crash survivable flight data recorder (CSFDR) data to depict the MA’s altitude from take-off to the time of ejection.

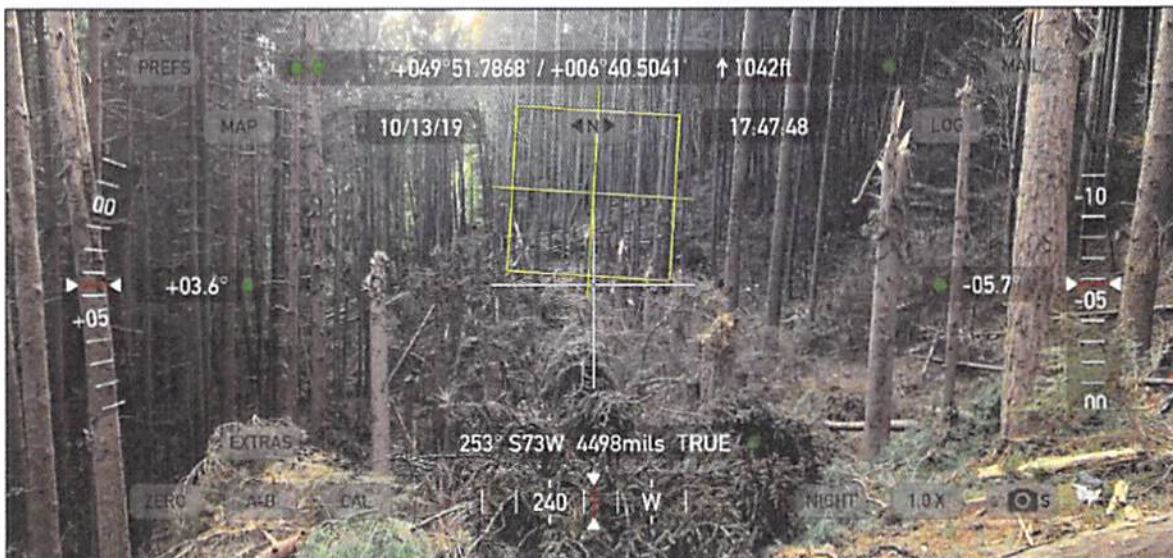
Figure 6: MA Impact Site (Tab J-27)

The MA continued to fly for another 42 seconds, after the MP ejected, and made initial contact with the tree tops at 15:11:24.87L, 8 nautical miles south (184 degrees true) of Spangdahlem AB (Tab J-27). The MA's parameters at the time of impact were: approximately 20-25 degrees of bank, 17 degrees nose low, 550 KCAS, and heading 248 degrees true (Tab J-30). Additionally, the MA had zero control inputs and an operable engine set at MIL power (Tab J-30). Upon contact with the trees, the MA was completely destroyed and shredded into mostly small pieces leaving a debris field approximately 1,000 feet long by 300 feet wide (Tab J-27). The terrain at the crash site is dense forest with steep, rapidly rising terrain and 100 foot tall trees as depicted in *Figure 6* (Tab J-27). There was no evidence of a post-impact fire at the site (Tab J-27). The impact resulted in zero casualties or fatalities (Tab O-3).

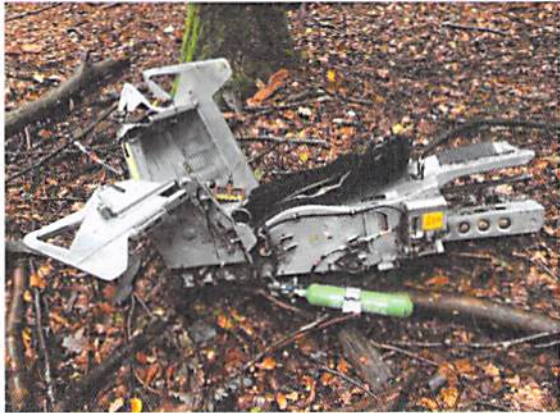
Figure 7: Ejection Seat (Tab Z-3)

instead of coming apart at the quick disconnects as designed, and the pitch control stabilization assembly (STAPAC) not rotating freely upon initiation of the ejection, which could have resulted in suboptimal pitch stabilization during the ejection (Tab J-13). The egress system was inspected within the 30-day, 12-month, and 36-month requirements (Tab D-23 to 24). The MP was current and qualified in AFE training, to include 120-day fit check, Egress, and Emergency Parachute Training (Tab G-28 to 29). The seat kit was equipped with a personnel locator beacon (PLB), but the beacon failed to activate upon man-seat separation (Tabs BB-9 and N-10). There are no other AFE issues pertinent to this investigation.

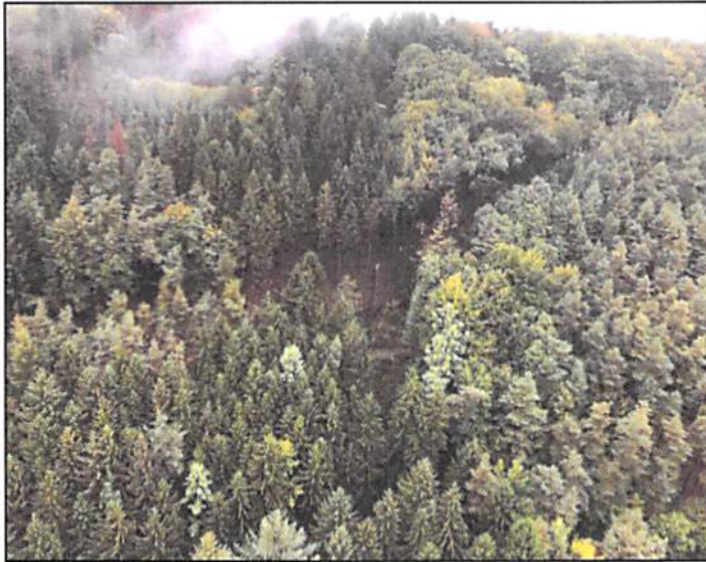
Figure 9: Helicopter Photo of Crash Site (Tab S-3)

R-24 and V-4.2). The MP was taken to Spangdahlem AB, where the helicopter landed at 1543L (Tab V-4.2). The weather was a minor factor, but the rescue helicopter remained below the low cloud deck throughout the recovery (Tab V-3.2 and V-4.2).

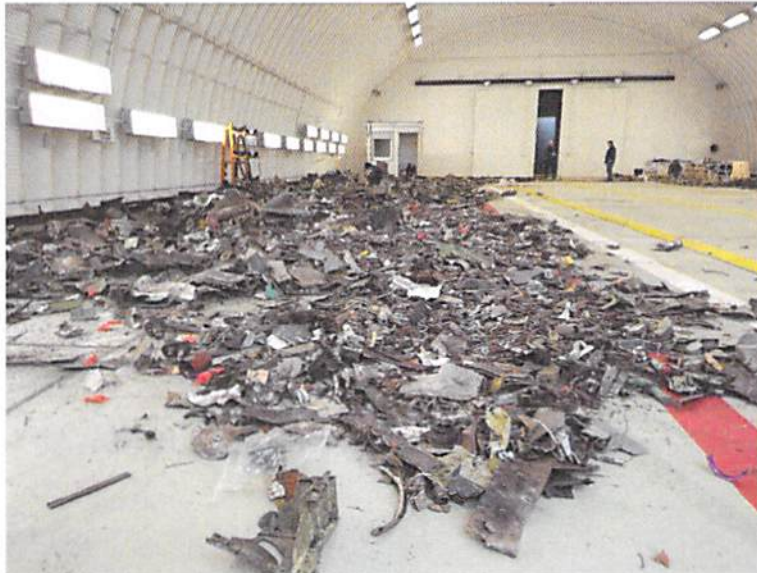
Figure 11: MA Wreckage Recovered in PAS (Tab S-9)

The MA impacted the trees 17 degrees nose low, 20-25 degrees right bank, and traveling approximately 550 knots (Tab J-30). The MA travelled approximately 1,000 feet through the forest and was completely destroyed during impact (Tab J-27). The majority of the MA was broken into pieces ranging in size from a few inches to a few feet (Tab J-27). Evidence of this is depicted in *Figure 11*. The largest debris recovered was 3 to 5 feet long (Tab J-27). The debris field was oblong in shape approximately 1,000 feet long and 300 feet wide at its widest point (Tab J-27).
