UNITED STATES AIR FORCE
AIRCRAFT ACCIDENT INVESTIGATION
BOARD REPORT

F-16CM, T/N 92-3907

LOCATION: OSAN AIR BASE, REPUBLIC OF KOREA

DATE OF ACCIDENT: 16 JULY 2013

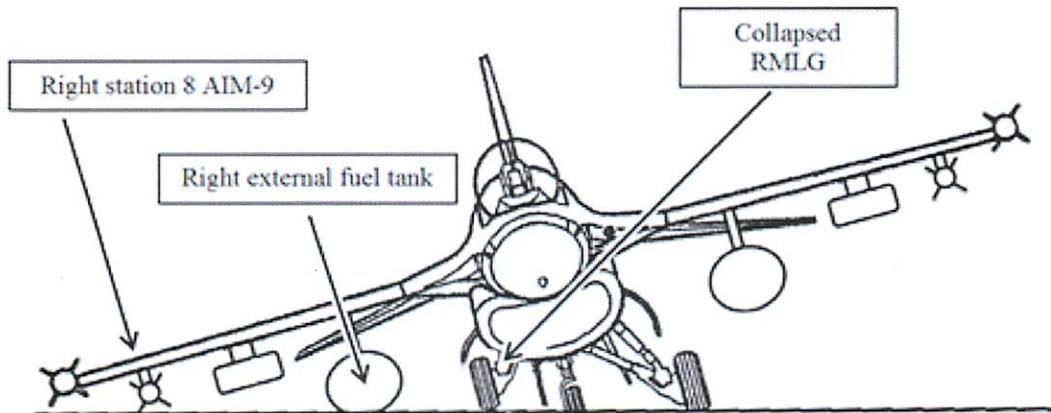
Tab Z-7

At 18:07L, the MA aircraft touched down (Tab J-8). The touchdown parameters were 8.0 feet per second (fps) (8 fps was recorded however the recorded precision is +/- 4 fps therefore actual vertical velocity range is between 4 fps and 12 fps), 12.7 degrees angle of attack (AOA), 1.5 times the force of gravity (g), throttle at idle, 156 knots calibrated airspeed (KCAS), 159 knots ground speed (KGS), and 600 ft down the runway (Tab J-2, Tab J-7). These parameters are all within the range of a normal landing (Tab J-39). Approximately 0.75 seconds later, the MA's right main landing gear collapsed (Tab J-36). Immediately, the MA's takeoff/landing configuration warning light illuminated, the pilot's heads up display flashed "WARN," and the voice message system stated "Warning Warning" (Tab J-8, Tab V-1.14). The MP quickly applied left roll control inputs and briefly kept the right wing off the runway (Tab J-2). Two seconds later, the MA's right external fuel tank contacted the runway (Tab J-2). One second later, at 147 KGS, the MA's station 8 AIM-9 missile contacted the runway (Tab J-2). With the increased drag on the right side of the MA, it skidded to the right side of the runway (Tab V-1.15). The aircraft continued moving forward and skidding right on its nose landing gear, left

main landing gear, and the right external fuel tank until it departed the runway nine seconds after touchdown and approximately 3,200 ft down the runway at 128 KGS (Tab J-2).

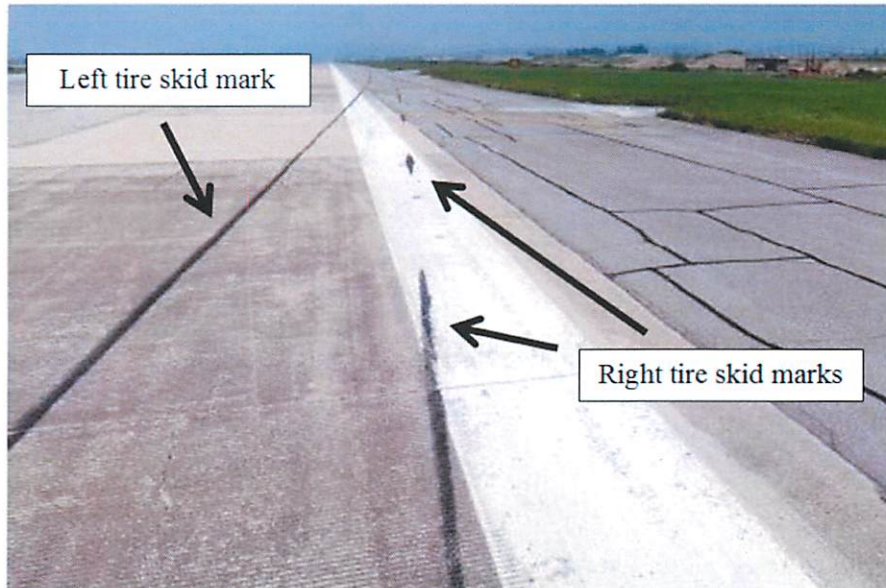
Tab J-11

The MA skidded to a complete stop 3,000 ft from touchdown and 3,600 ft from the approach end of the runway (Tab J-2, Tab S-7). The initial touchdown point could not be confirmed visually due to numerous touchdown skid marks on the runway and was therefore estimated using data from the CSFDR (Tab J-10). The first clear mishap-related marks on the runway were caused by the right external fuel tank and the station 8 AIM-9 missile fins scraping on the runway, starting at a point just past the first arrestment cable, approximately 1,400 feet from the approach end of the runway (Tab J-10). Starting approximately 1,700 feet from the approach end of the runway, there were skid marks of various lengths and shapes caused by the RMLG tire (Tab J-10). Because the RMLG collapsed, it was able to move up and down freely as it skipped along the surface of the runway, thus creating a series of short skid marks (Tab J-51). There was a continuous skid mark caused by the left main tire starting approximately 2,000 ft from the approach end of the runway and extending to the point where the MA departed the runway (Tab J-10). There was no damage to private property (Tab P-2).

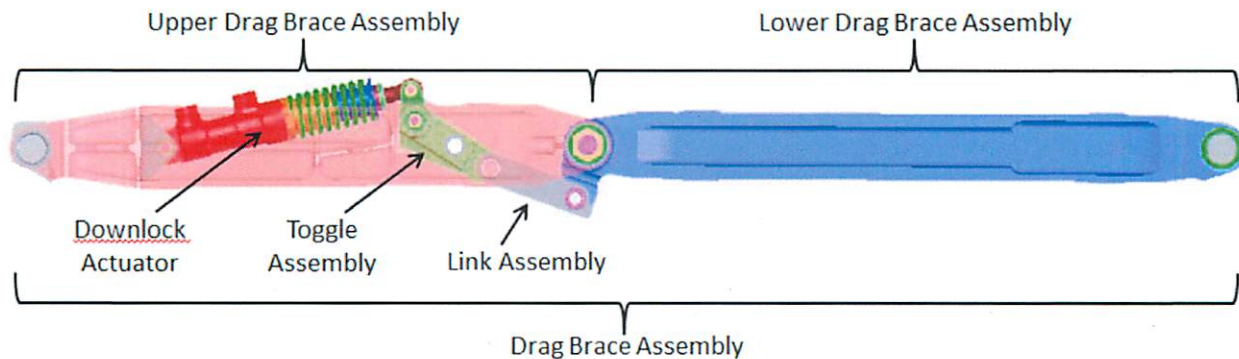
Tab J-328

The main landing gear drag brace assembly is a major structural load bearing member of the landing gear (Tab J-39). It holds the landing gear in the extended position during taxi, take-off, and landing (Tab J-39). The drag brace attaches to the fuselage in the main wheel well and to the tension strut assembly at the lower end of the LG (Tab J-39). The drag brace is made up of five major components: the upper drag brace, the lower drag brace, link, toggle, and the downlock actuator (Tab U-18). The upper and lower drag brace are structural members. When the drag brace is extended, it is locked into position by the link, toggle and downlock actuator (Tab J-39). The downlock actuator is a spring loaded hydraulic actuator that uses spring force to keep the link and toggle in an over center locked position and uses hydraulic pressure to release the lock for landing gear retraction (Tab J-39).

After lowering the gear, the downlock actuator holds the toggle/link assembly in the over center locked position using spring forces only (Tab J-40). Hydraulic pressure is only used to unlock the toggle/link assembly during gear retraction (Tab J-40). CSFDR analysis indicates no hydraulic pressure was supplied to the downlock actuator (resulting in an unlocked toggle/link assembly) (Tab J-40). This in turn indicates that the landing gear handle remained in the down and locked position during the landing phase (Tab J-40).

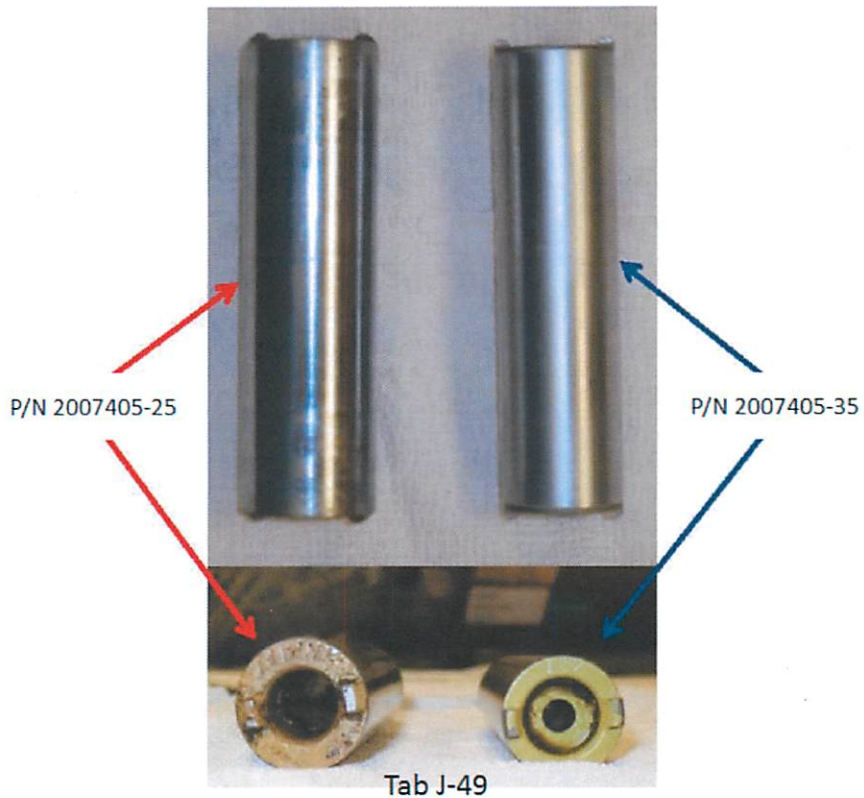
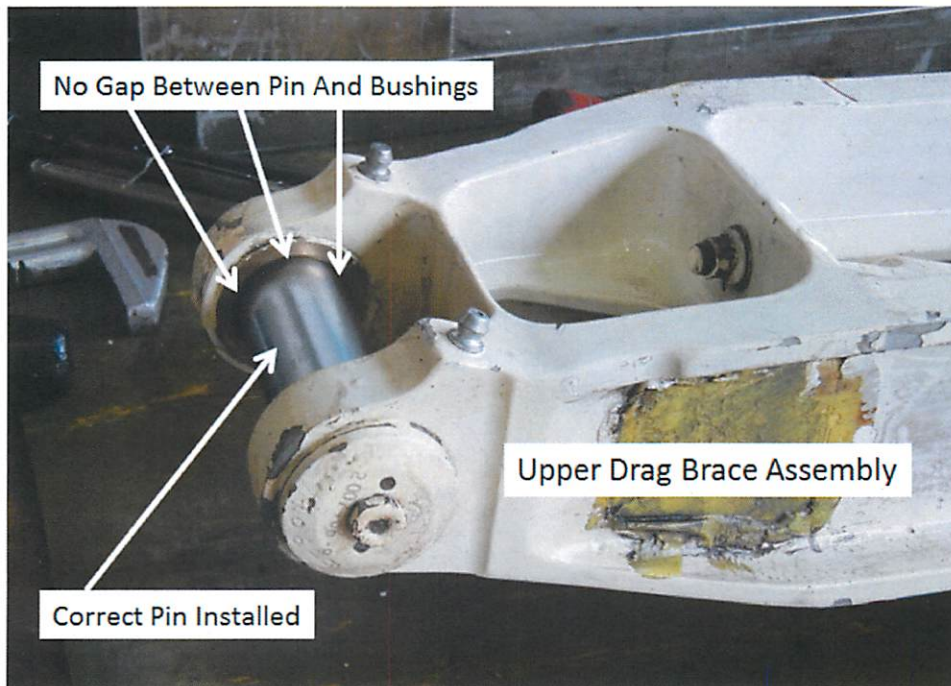
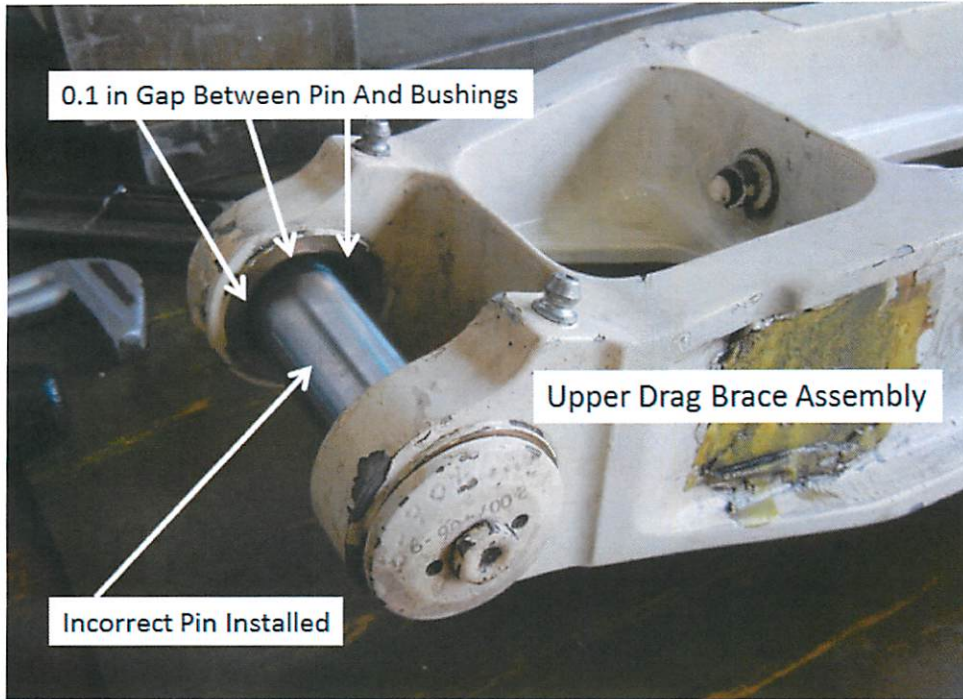
Tab Z-5

The inner bushing faces on the upper drag brace attach lugs had abnormal wear indications showing that there was significant play available to the attach lugs (Tab J-41). The upper drag brace attach lug bushings and drag pin attach lug also showed wear markings consistent with the installation of a smaller pin installed into the bushings (Tab J-38 through Tab J-39).
