2019 June 10th

Office of Air and Space Bureau

About factor of F-35A fighter crash and relapse prevention measures

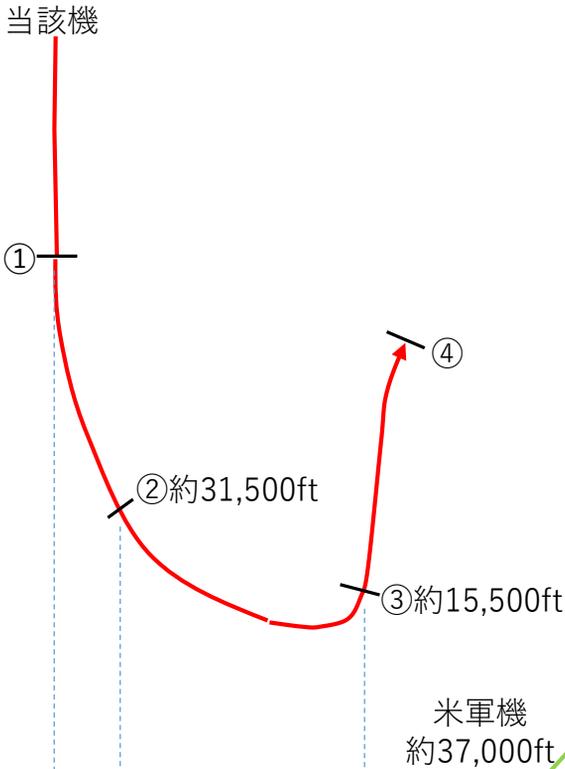
【水平面図】

1 At around 19:25, the aircraft sent that it had shot down two opposing aircraft for training.

In response to the descent instruction of, the machine sends "Yes. OK" and turns left descent.

After receiving a left turn instruction to take, the machine turned to the left, "Yes, knock,
Send it off (approx. 15,500 ft).

4 At about 19:26:30, the radar track of the aircraft disappeared and crashed shortly after.

航跡概要図 (イメージ)

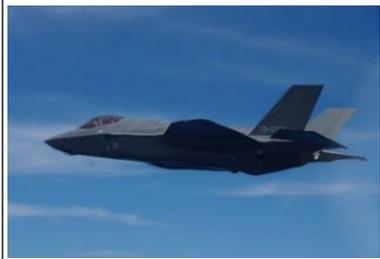
名称	F-35A 戦闘機
機種

機体	全長：約16m 全幅：約11m 全高：約4m
型式	単座（1名）
推力	43,000lb×1発
速度	最大M1.6
航続距離	航続距離：約2,200km 戦闘行動半径：約1,093km
搭載可能弾薬	AIM-120C :4発(内装) AIM-9X :2発(外装) JDAM(2,000lb) 等

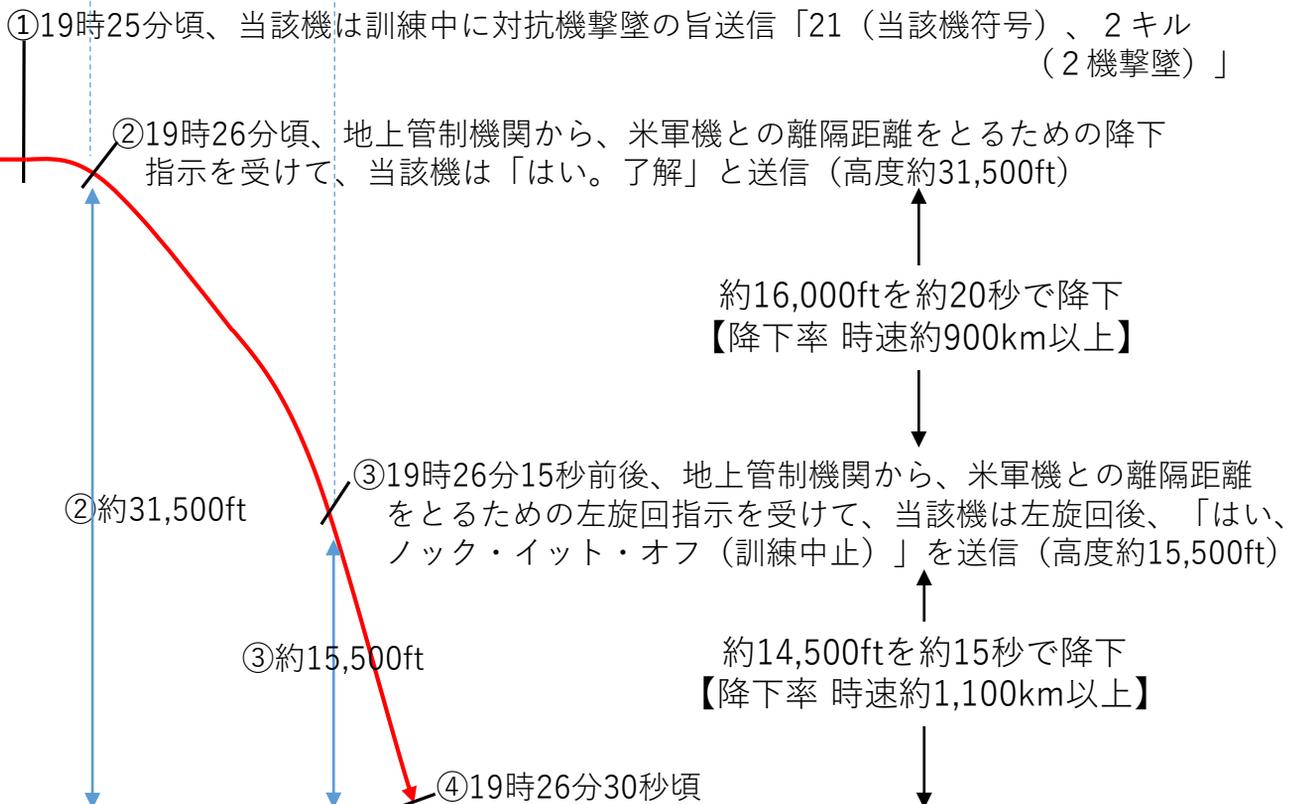
【垂直面図】

A sudden descent attitude with an average descent rate of about 900 km / h or more between 2 and 3.

3 to 4 for about 15 seconds, the average descent rate is about 1,100 km / h or more.

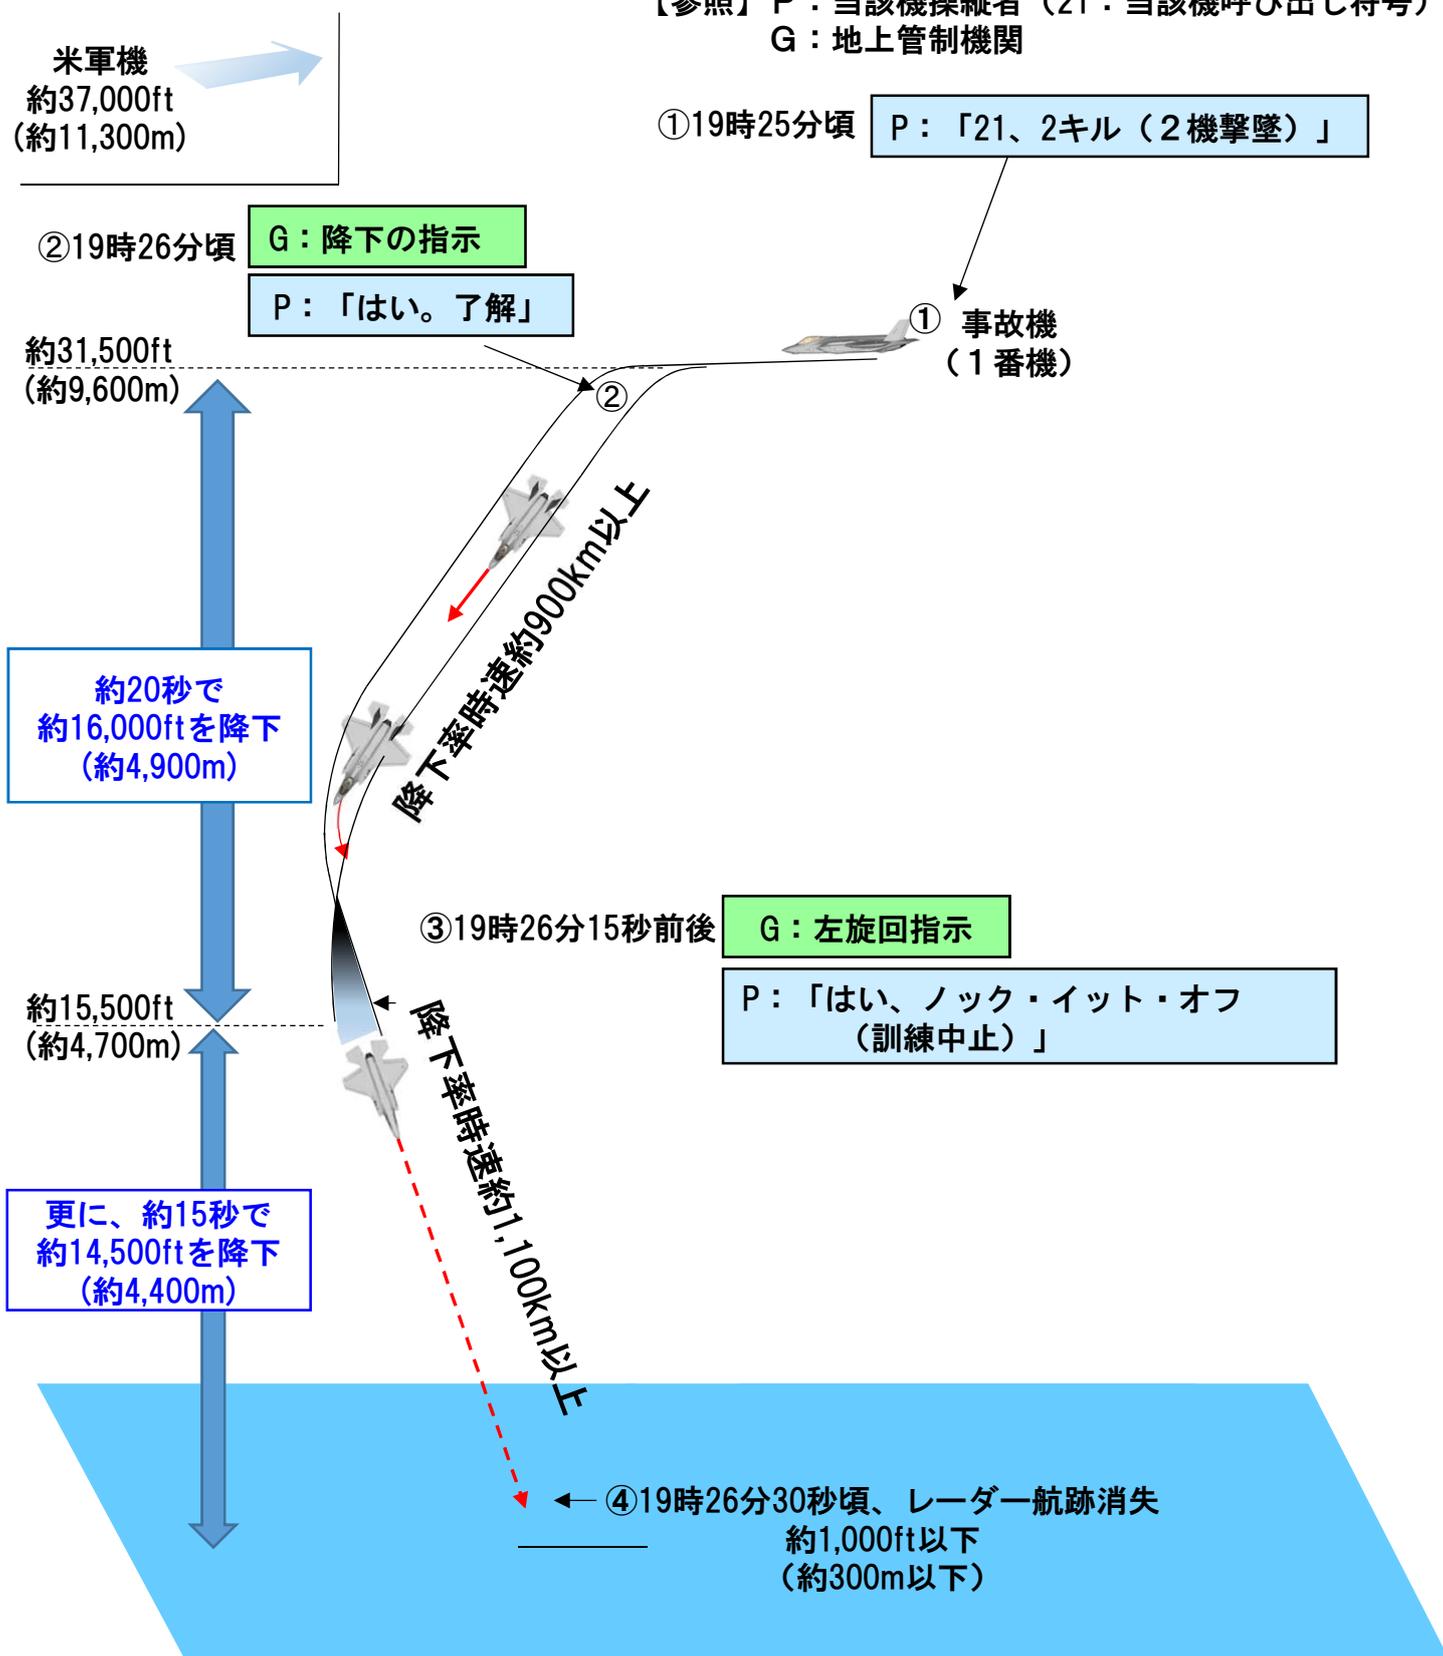
航跡概要図 (イメージ)

【参照】 P : 当該機操縦者 (21 : 当該機呼び出し符号)
G : 地上管制機関
