2019 June 10th

Office of Air and Space Bureau

### About factor of F-35A fighter crash and relapse prevention measures

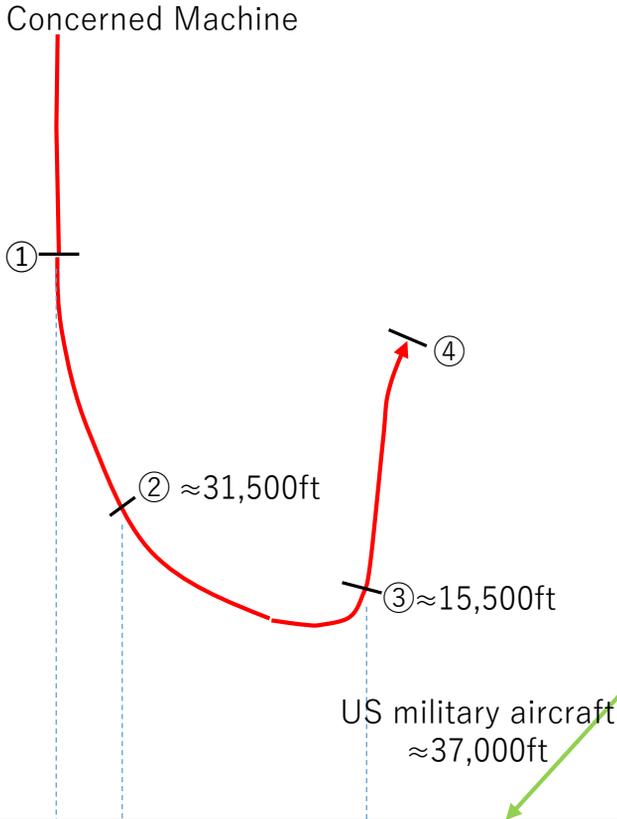
## 【Horizontal View】

1. At around 19:25, the aircraft transmitted that it had shot down two opposing aircraft for training.
2. At 19:26, upon receiving a descent instruction from the ground control agency to separate from a US military aircraft, the aircraft sent a "Yes. Roger that" message and starts a left descending turn (at approximately 31,500ft).

3. At around 19:26:15, after receiving an instruction from the ground control agency to turn left to separate from a US military aircraft, the F-35A turned left and sent "Yes, knock it off (stop training)" (at about 15,500ft). At this time, the transmission is performed with a calm voice. Between points 2 and 3 there is a sudden descent attitude with an average descent rate of about 900km/h or more.
4. At around 19:26:30, the radar track disappeared and the aircraft crashed shortly after. Between points 3 and 4, for about 15 seconds, the steep descent attitude continued, with an average descent rate of 1,100km/h or more. The aircraft is estimated to have crashed shortly after. There is no evidence of an ejection during that time. In addition, the fuselage was destroyed violently, with parts and fragments scattered on the seabed.

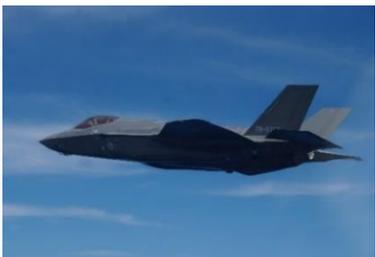
Name	F-35A
	Fighter
Model

Aircraft	Length: 16m Width: 11m全 Height: 4m
Type	Single seat (1 person)
Thrust	43,000lbs×1 engine
Speed	Up to M1.6
Cruising Distance	Range : approx 2,200km Combat radius : approx 1,093km
Armament	AIM-120C :4 (interior) AIM-9X :2 (exterior) JDAM(2,000lb), etc

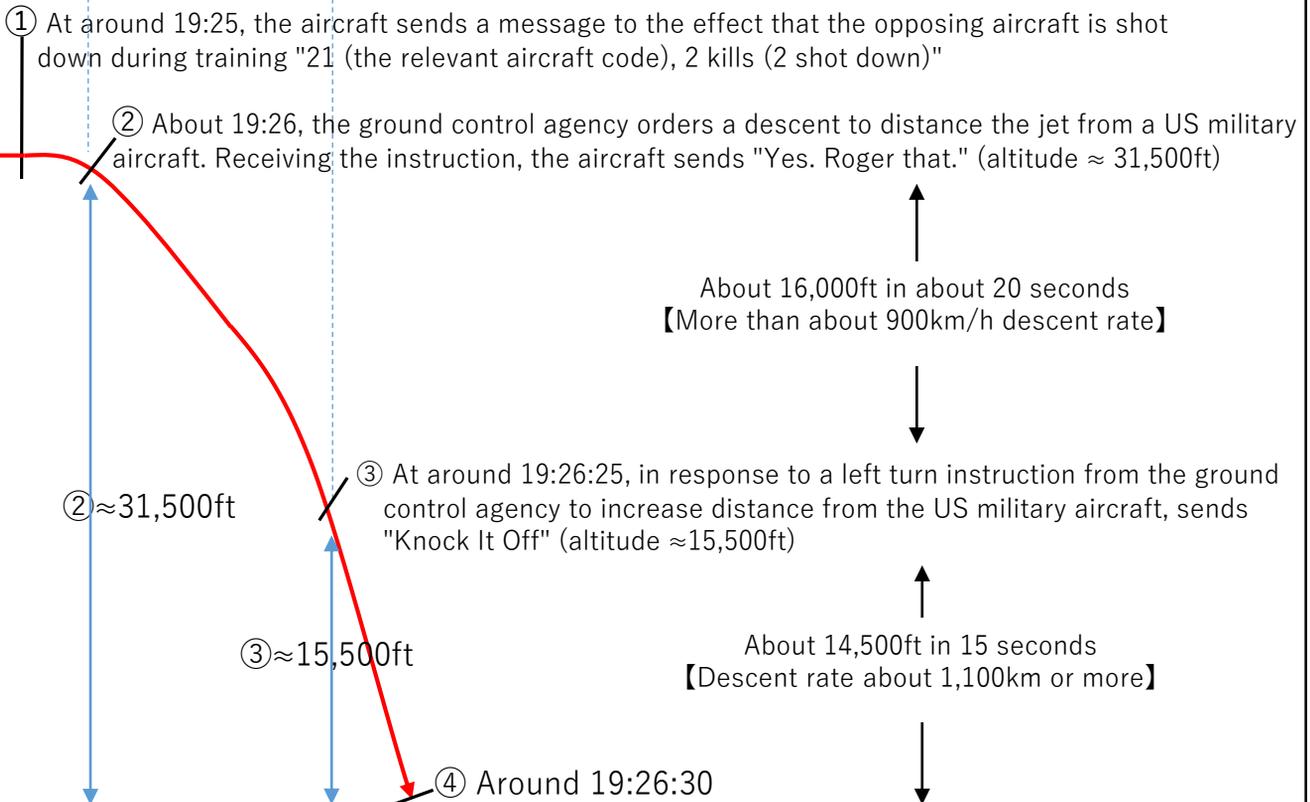
## 【Vertical View】

(3) Between points 2 and 3, the average descent rate is about 900km/h or more, between points 3 and 4, the average descent rate is 1,100km/h or more, and there is no possibility of loss of thrust or a defect in the airframe structure. Even at low altitudes no recovery maneuver was seen, so it is presumed that the pilot had fallen into "spatial disorientation" (a state of losing balance), and is highly likely that the pilot was not aware of it.

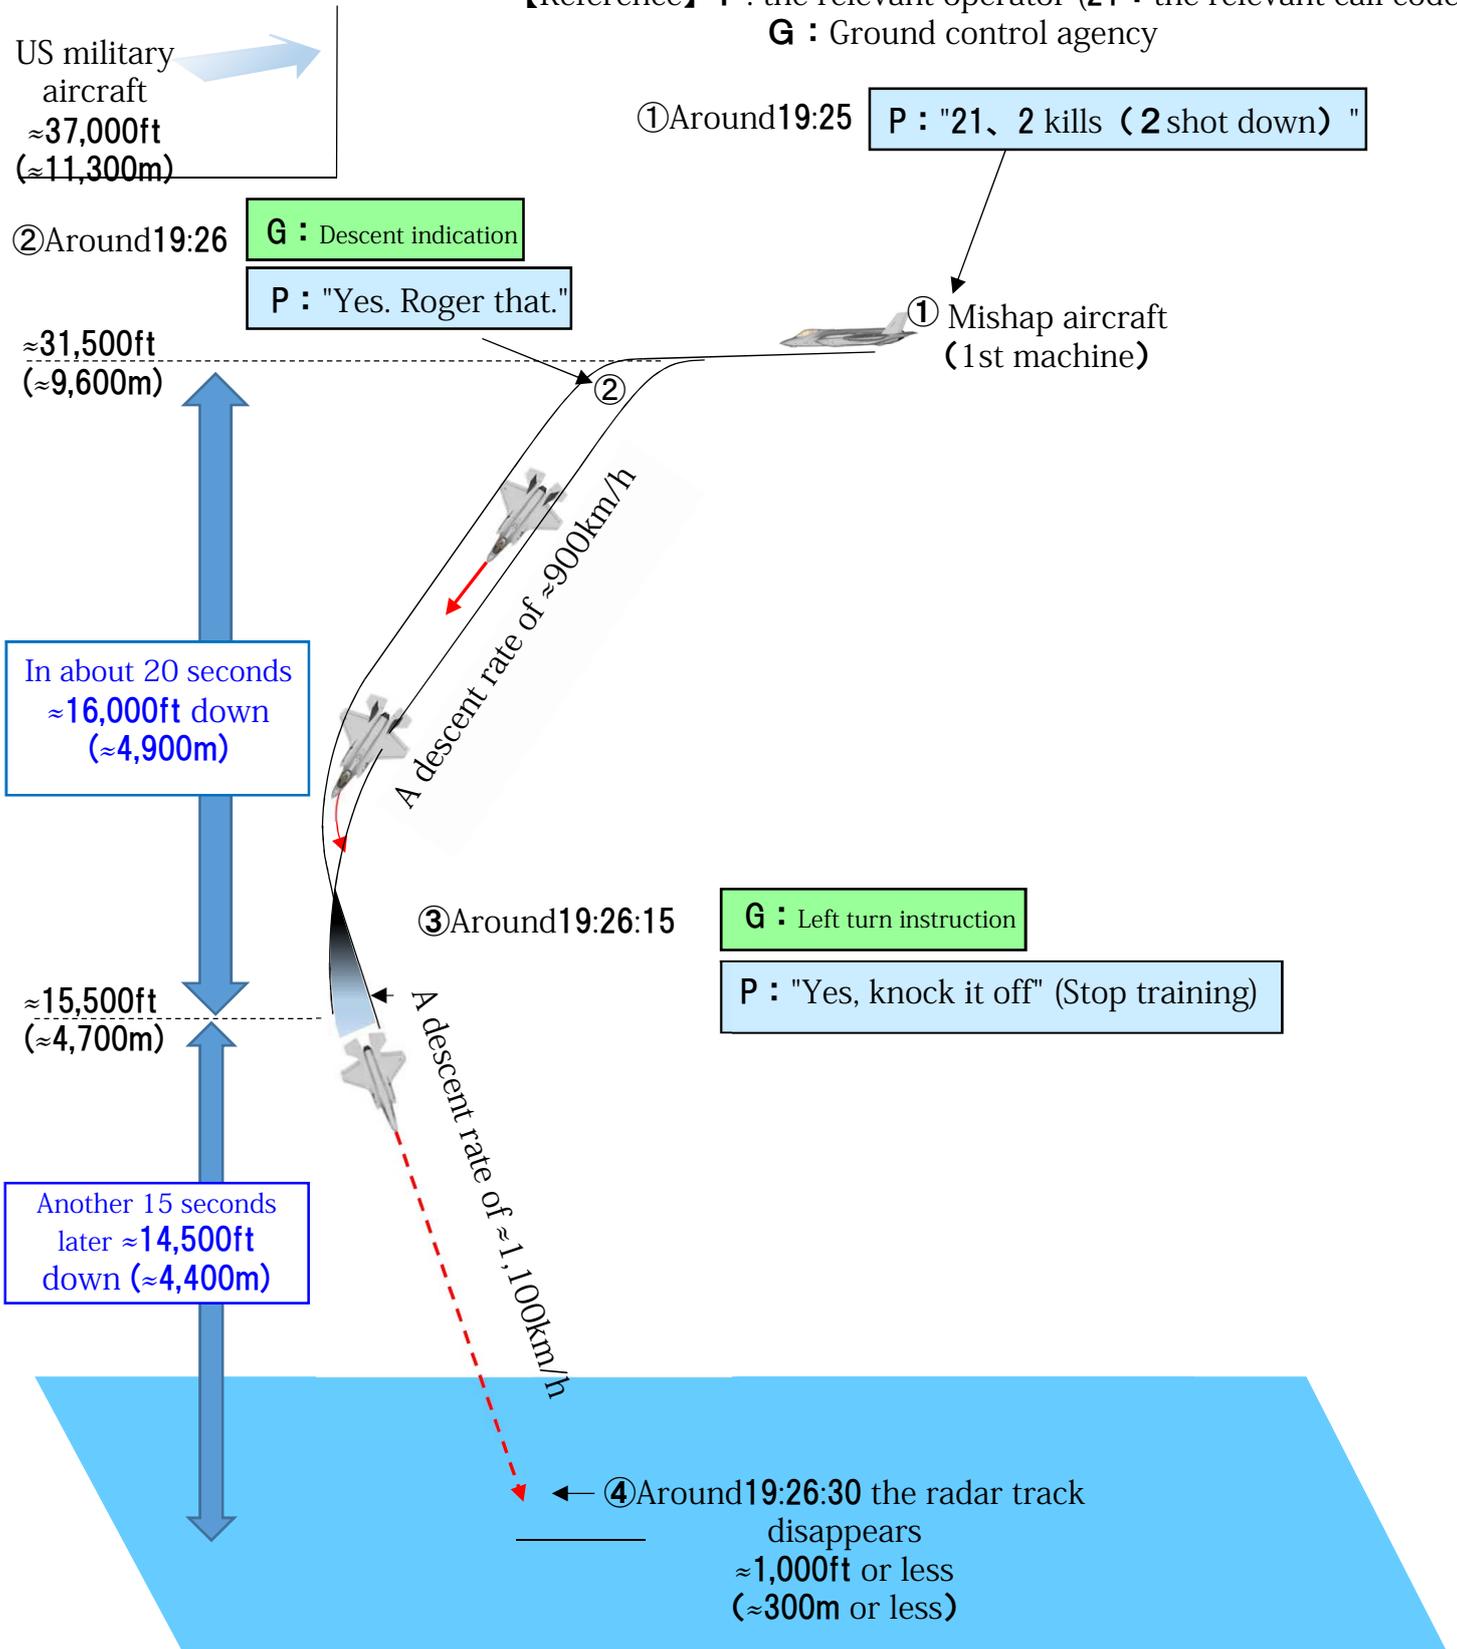
# Wake Outline Map (Image)

【Reference】 P : the relevant operator (21 : the relevant call code)  
G : Ground control agency
